SUBJECT: Single Engine Service Bulletin SEB93-5 Revision 2, Lower Forward Doorpost and Strut Fitting Inspection and Modification.

SEB93-5  
Revision 2

LOWER FORWARD DOORPOST AND STRUT FITTING INSPECTION AND MODIFICATION

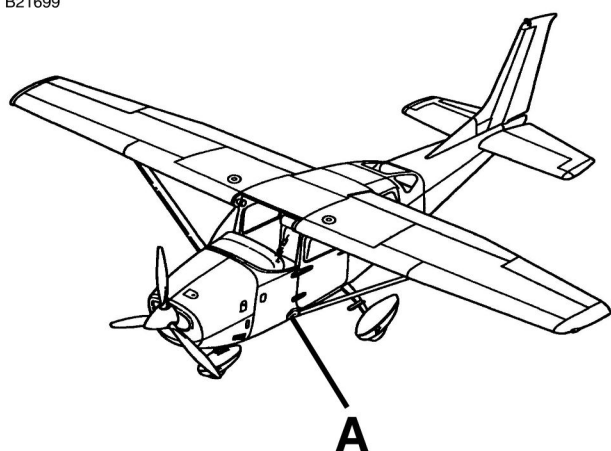
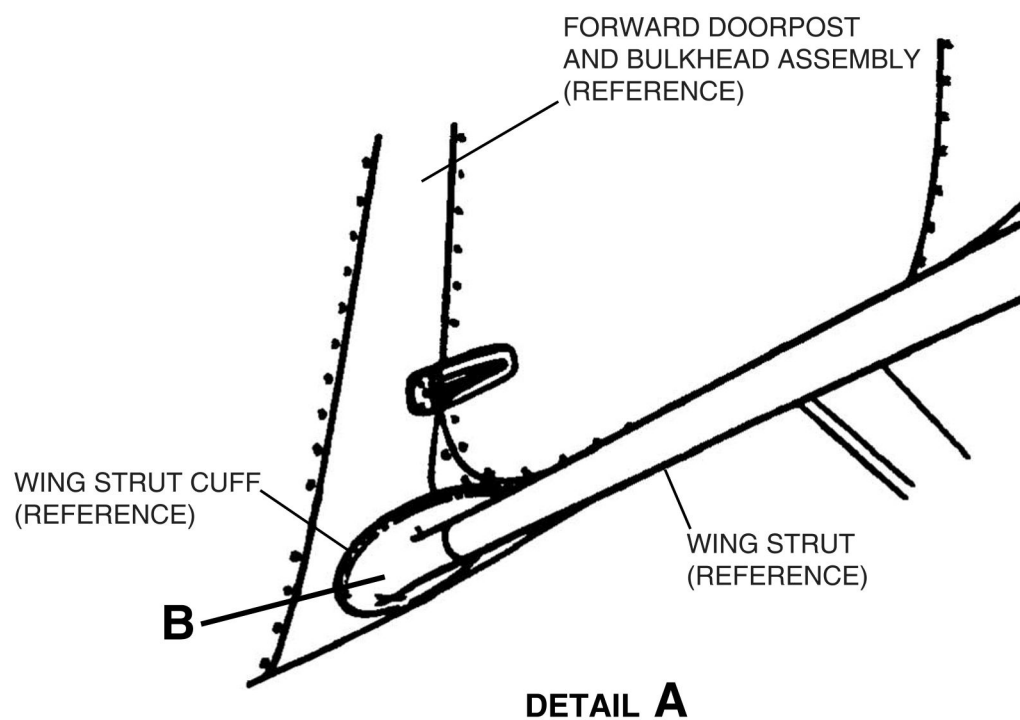
Figure 1. Lower Doorpost Bulkhead and Wing Strut Fitting Inspection (Sheet 1)

U206/TU206 SHOWN  
(207/T207 TYPICAL)

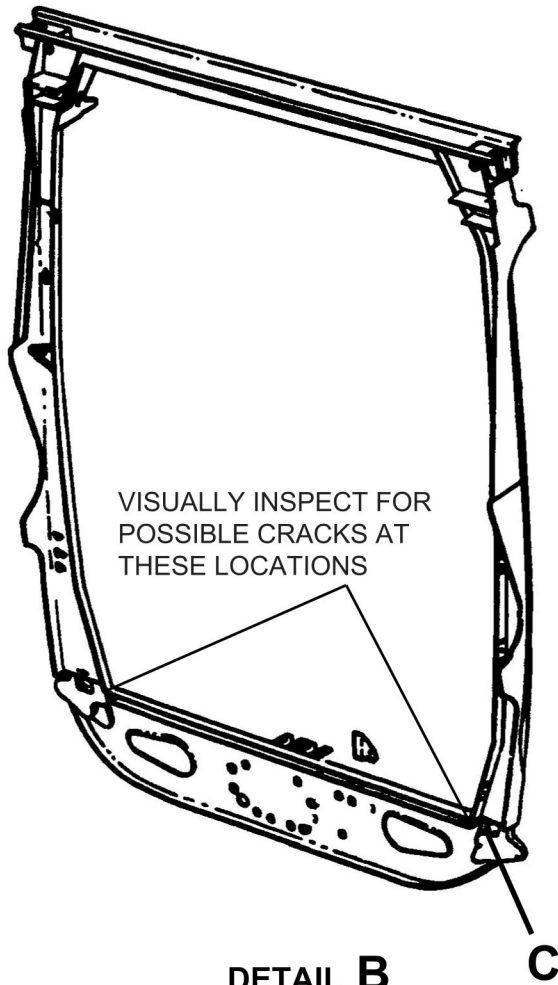
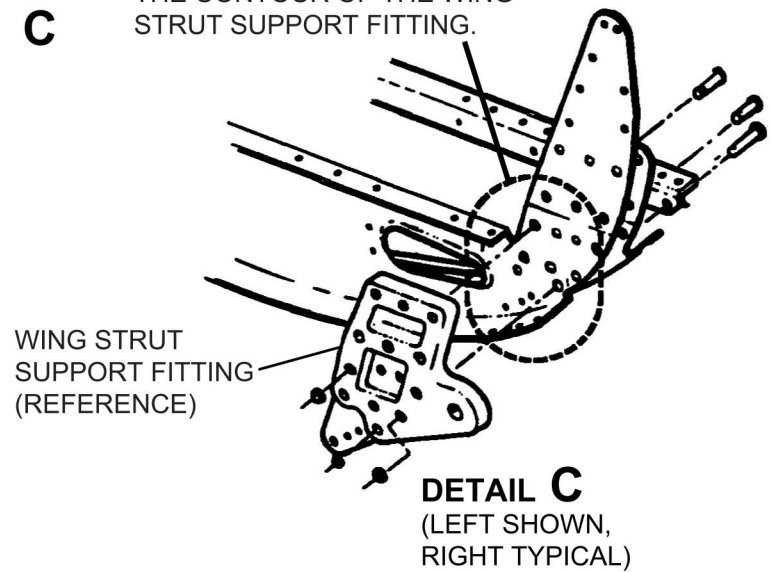
Figure 1. Lower Doorpost Bulkhead and Wing Strut Fitting Inspection (Sheet 2)

- B. (Refer to Figure 1, Sheet 2, Details B and C.) Visually inspect areas shown for cracks. If there are cracks present, they should be visible at the intersection of the doorpost and the forward doorpost bulkhead. Look for cracks that follow the contour of the wing strut support fitting.

**CRITICAL INSPECTION AREA**  
LOOK FOR CRACKS FOLLOWING  
THE CONTOUR OF THE WING  
STRUT SUPPORT FITTING.

- C. If cracks are present:
    - (1) For 210-5 (205), 206, P206/TP206, U206/TU206 model airplanes, install SK206-42D (or later revision) prior to further flight.

- (2) For 207/T207 model airplanes, install SK207-19A (or later revision) prior to further flight.
  - D. If cracks are not present, repetitive inspections of the critical area shall be accomplished per the compliance section of SEB93-5, or later revision.
