## AERO ACCESSORIES, LLC SERVICE BULLETIN

**SERVICE BULLETIN: SB-011**

**SUBJECT: Possible Damaged O-Ring**

**APPLICABILITY: Tempest® Electronic Fluid Pump**

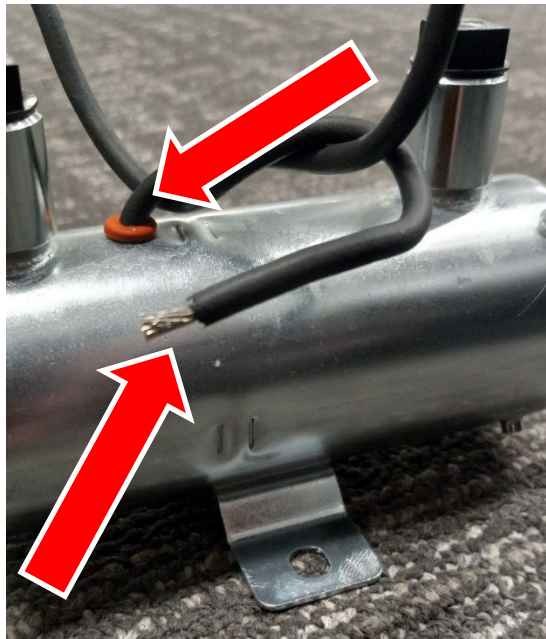
**Figure 1**

**Background:** There has been a report from the field of a fluid leak in a Tempest® Electronic Fluid Pump. The area of the leakage was observed at the grommet and, or the end of the lead wire. See Figure 1.

**Compliance:** When installing a Tempest® Electronic Fluid Pump, operate the pump with fluid. Verify that no fluid is leaking from the fitment points, the end of the lead wire, or around the grommet, See Figure 1. If there is evidence of a leak, do not use the pump, return the pump for an exchange.

**Previously Installed Pumps:** Tempest® Electronic Pumps that have previously been installed need to be reinspected for leaks within 10 flight hours or 45 days from the effective date of this service bulletin, whichever occurs first. The inspection must be done while the pump is operating and the fluid is present.

If there is evidence of a leak, do not use the pump, return the pump for an exchange.

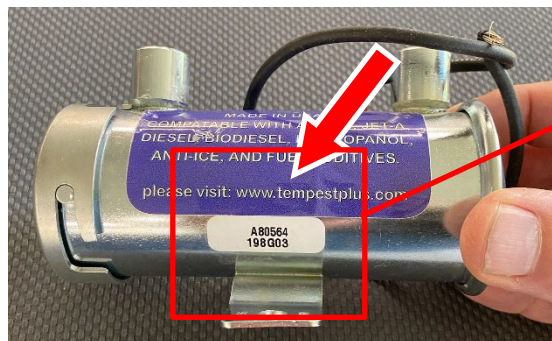
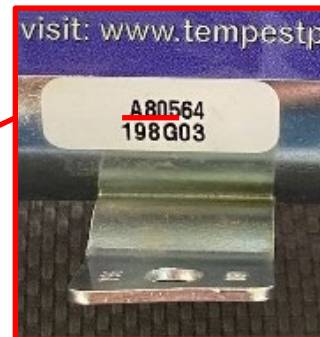
SERIAL  
NUMBER  
198G03  
LOT CODE

Lot Number  
is located  
on separate  
label above  
mounting  
flange.
