Service Letter Number: SL-005

Subject: SIDE Wear Indicator Port Instructions

Applicability: **240 & 400 Series Dry Air Pumps**

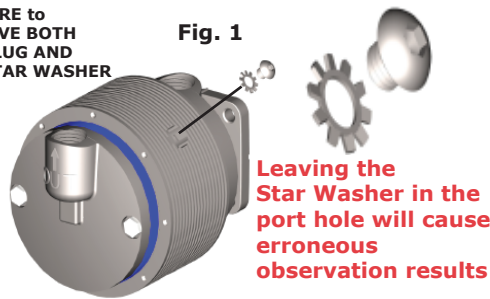
Fig. 1

- d. Remove the Inspection Port Plug AND STAR WASHER, Fig. 1. Failure to remove the star washer will cause a false indication.
- e. While looking into the indicator port, have an assistant slowly move the propeller by hand in the normal direction of rotation until a vane slot is centered in the port, Fig. 2. If you go too far just keep turning it to the next slot.

BE SURE to REMOVE BOTH the PLUG AND the STAR WASHER

- g. Observe the plunger's indicating bead land position, Fig. 4. If the indicating bead land is touching the barrel end, the vane is worn to the service limit.
- h. If the vanes are within service limit and the pump is otherwise serviceable, clean the threads on the port plug, install a NEW STAR WASHER and torque to 45-50 inch-pounds.

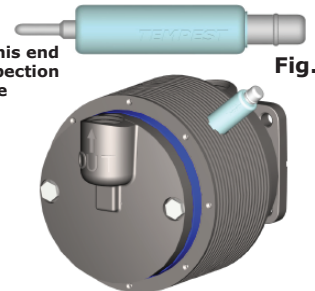
Fig. 3

- f. Insert the Vane Wear Indicating Tool, Fig. 3, into the inspection port as illustrated in Fig. 3. Hold the barrel securely and squarely against the pump body. With your fingertip, gently push the plunger into the pump's inspection port. When the plunger touches the vane, slight vane movement may be felt if the vane is not at the bottom of it's slot. Apply pressure until the vane reaches the bottom of its travel.

**P/N: 82-50122-2A6
Vane Wear Indicating Tool**

Insert this end into inspection port hole
