## Service Bulletin SB-11

**February 10, 2020**

### I. SUBJECT

This Mandatory Service Bulletin addresses the elevator trim system, specifically the cable to drive chain connection on some Cessna 208 series aircraft. The defect could result in a loss of continuity in the elevator trim control system resulting in loss of the pilot adjustability of elevator trim.

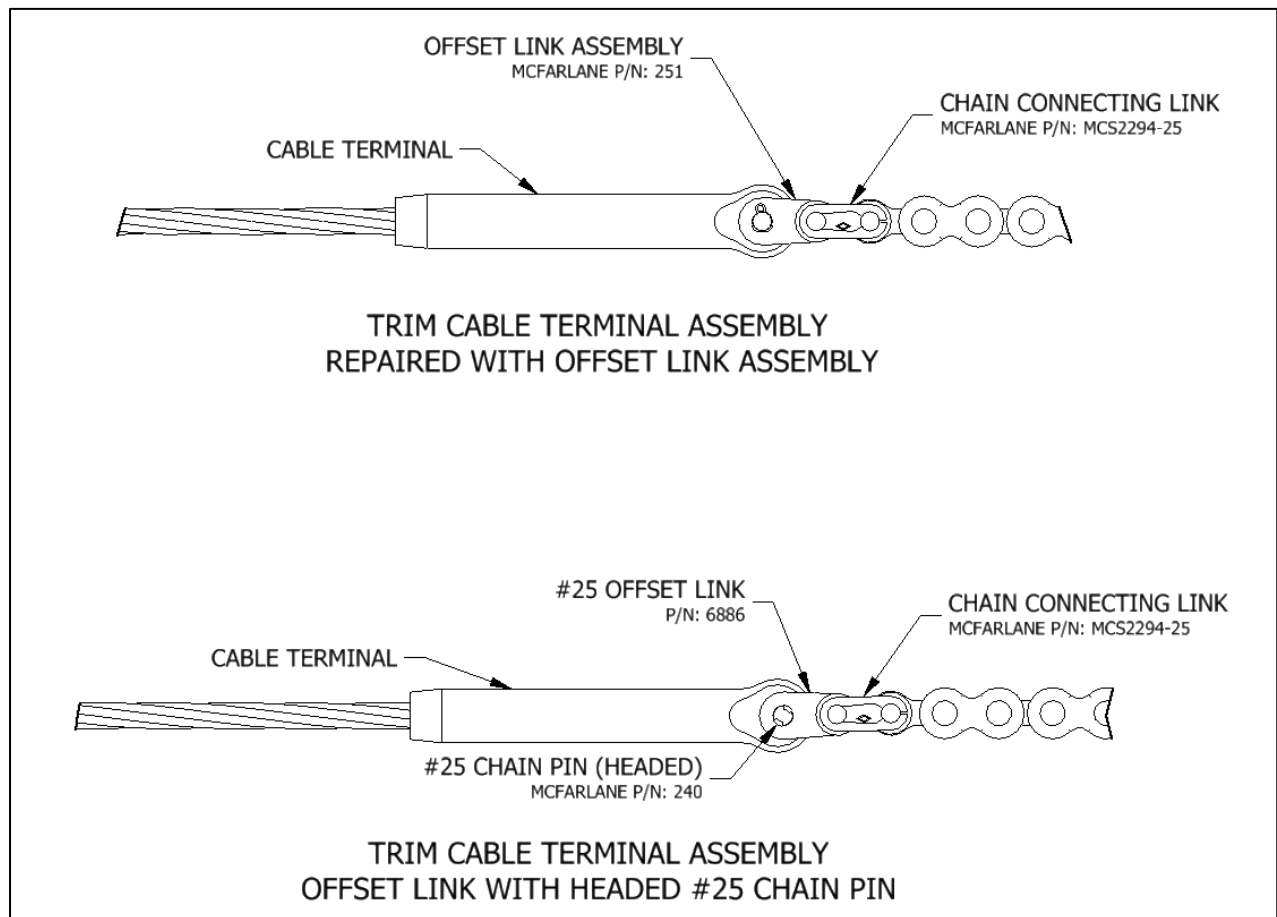
Figure 1 - Comparison of Trim Cable Terminal Assemblies

A possible defect in the chain pins that retain the offset chain connector links has been detected. These connector links and their riveted chain pins connect the interconnect cables to the #25 drive chains in the aircraft elevator trim system. The offset chain link is connected with a riveted chain pin to the trim cable terminal during manufacture of cable assemblies. Oversize holes in a specific batch of offset connector links have been found during recent production. The oversize connector holes could result in insufficient chain pin head size to properly retain the chain pin in the connector. This service bulletin affects a small group of trim cables released between May 6, 2019 and December 13, 2019.

The affected cable assemblies were released from McFarlane Aviation Products (McFarlane) between May 6<sup>th</sup>, 2019 and December 13<sup>th</sup>, 2019. Search the aircraft maintenance records for replacement of the elevator trim cable assemblies listed under Section IV. The affected cable assemblies have a riveted chain pin connecting the offset link to the cable terminal fitting. Note that only McFarlane cable assemblies use an offset link between the cable terminal and the chain connecting link. The original Cessna Aircraft Company cable assemblies does not use an offset link.

3. With rigging tension off the cable, locate the offset link and chain connecting link; see figure 1 for illustration and description of the connecting hardware. *NOTE: Only McFarlane trim cable assemblies utilize an offset link, and a chain pin connection, to connect to the connecting link.*

4. Disconnect cable by removing chain connecting link.
5. Remove headed clevis pin as follows:
  - a. Support the side of the offset link and the attached cable terminal with a bucking bar or other appropriately sized metal bar.

- b. Use a .090 pin punch to drive headed clevis pin out of offset link and discard pin (P/N: 240), and offset link (P/N: 6886).
6. Install new Offset Link Assembly as follows:

- a. Align offset link pin hole with cable terminal pin bore.
  - b. Insert clevis pin through both offset link and cable terminal.
  - c. Press and hold pin against offset link.

- d. Install cotter pin through end of clevis pin and bend around to secure.
  - e. Inspect the cotter pin for proper installation.
7. Install the new chain connecting link (P/N: MCS2294-25)
