McFarlane Aviation, LLC.
696 East 1700 Road
Baldwin City, KS 66006
(785) 594-2741 Fax: (785) 594-3922
www.mcfarlaneaviation.com
1-800-544-8594
sales@mcfarlaneaviation.com

Service Bulletin SB-12

December 12, 2023

This Mandatory Service Bulletin addresses a potential failure condition of the outlet fitting on McFarlane Aviation, LLC. (McFarlane) produced, MC0513120 series Fuel Selector Valves used in various Cessna 170, 172, 175, and 177 series aircraft. The failure condition presents itself on valves that have been overhauled, or otherwise reassembled, since the original assembly by McFarlane and have had excessive torque applied to the outlet fitting.

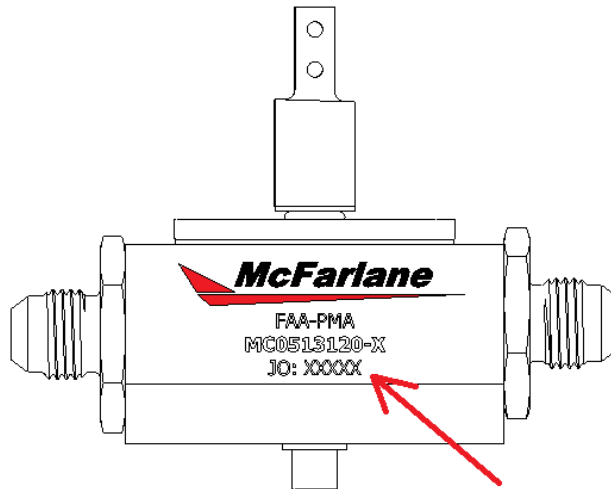
Lot numbers can be found on the body of the valve, opposite the outlet port, in the area shown in Figure 1 below. Lot numbers are either laser engraved on the body or printed on a polyester label.

Figure 1: MC0513120 series valve showing part marking location. Arrow specifically points to location of lot number.

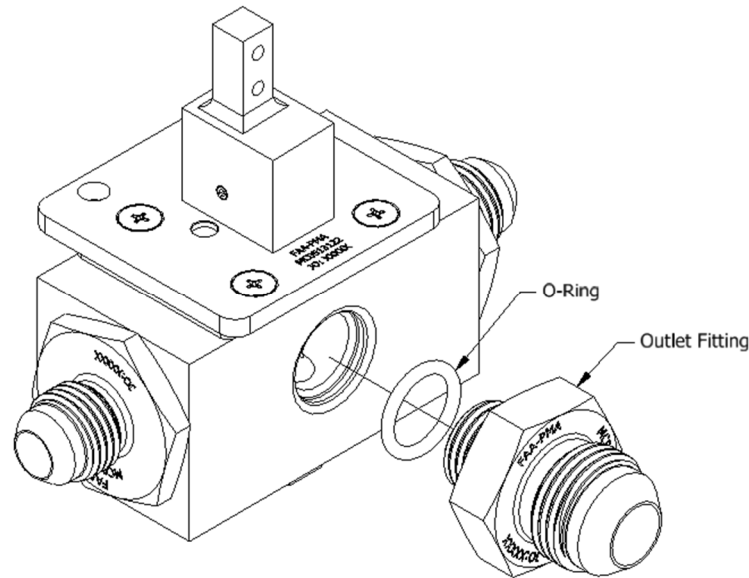
All fuel valves will require one (1) new outlet fitting and one (1) new outlet O-ring. (See Figure 2). These components are part of the relevant McFarlane service kit.

Figure 2: MC0513120 series Fuel Selector Valve w/ Outlet Fitting and O-ring

All repaired valves must use an MCM83248/2-906 O-ring for the outlet port. For the outlet fitting, use the table below to confirm the correct outlet fitting P/N for the repair of your Fuel Selector Valve:

1. Remove all safety wire from the outlet fitting.
2. Remove the old fuel outlet fitting from the valve body and discard the old O-ring.
3. Destroy the old outlet fitting in a manner that prevents future use (EX: damaging the threads, drilling into the fitting body, etc.). **NOTE:** Record of destruction is required for compliance with this service bulletin.

4. Clean and inspect outlet threads on valve body for any gouges, scratches, burrs, or defects that could affect proper sealing.
5. Lubricate the new outlet O-ring (P/N: MCM83248/2-906) with aviation motor oil (SAE Standard J1899 or equivalent)

6. Slide new outlet O-ring around threaded end of the new fitting until making contact with the wrench flats.
7. Lubricate new outlet fitting threads with a thin coat of general purpose grease to prevent galling.

8. Thread new outlet fitting into the valve body and tighten until sealed (Torque fitting to 13-14 ft-lbs. or 156-168 in-lbs.)
9. Resecure drain plug to outlet fitting with .021", or larger, safety wire.
