SERVICE BULLETIN NUMBER 2

October 4, 1999

Subject: Fitting cracks in a selected group of McFarlane Aviation replacement engine controls.

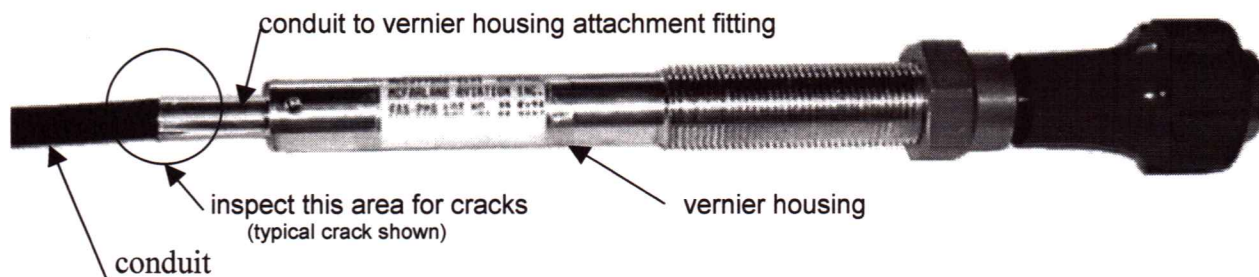
Figure 1

General: McFarlane Aviation has detected substandard strength in part of a specific lot of our conduit to vernier housing attachment fittings that are used in our vernier style push-pull engine controls. This fitting is swaged during manufacture to secure the conduit to the vernier housing. It has been determined that some fittings will crack in the swaged area when subjected to abnormal side loads being applied to the conduit perpendicular to the conduit centerline. It is possible that the cracks could eventually cause detachment of the conduit from the vernier housing. This condition could result in full or partial loss of engine mixture control or propeller control.

Inspection Requirements: Obtain access to the backside of the aircraft dash-panel and visual access to the backside of the McFarlane vernier push-pull control. Visually inspect the conduit to vernier housing fitting for cracks in the swaged area. The cracks will usually start at the conduit end of the fitting and extend towards the vernier housing. See *Figure 1*. Remove from service all controls with a cracked fitting.
