## Service Bulletin SB-7, revision A

August 20, 2015

### SUBJECT

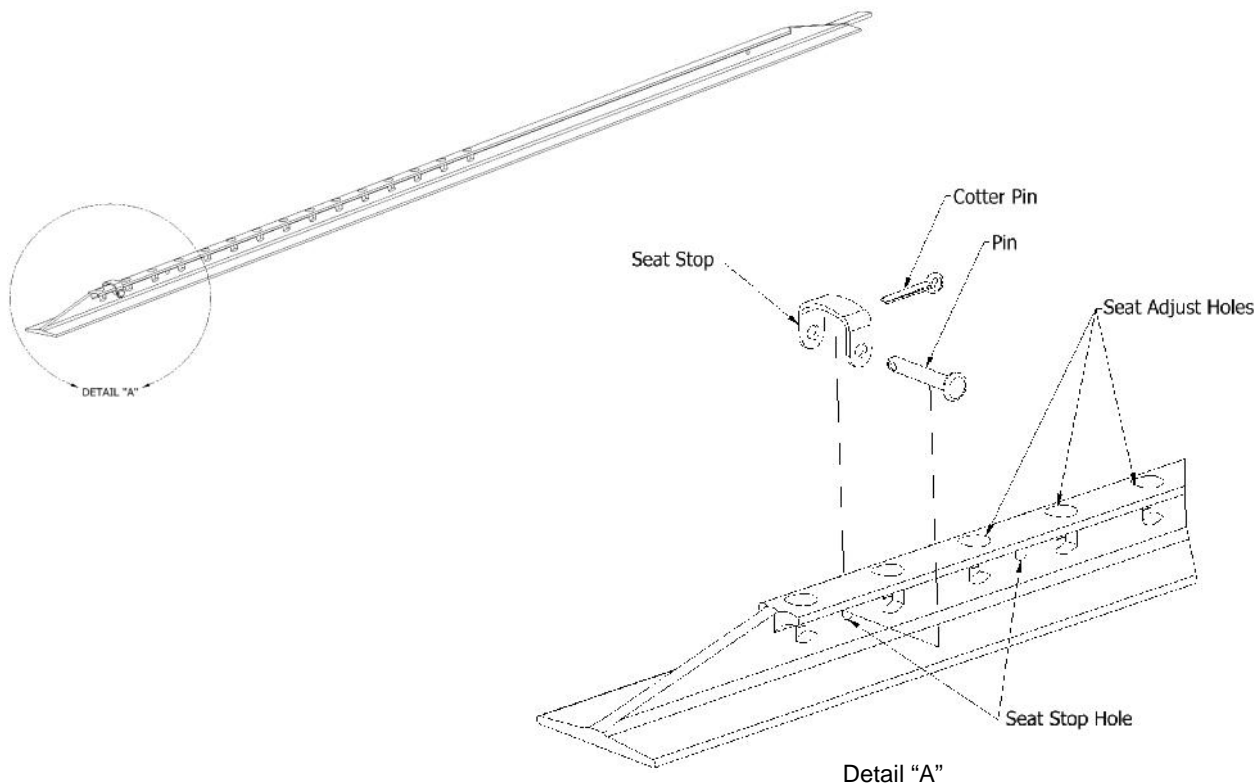
Many of the seat rails installed in Cessna aircraft have holes drilled in the vertical web for installation of seat travel stops. The stops are typically installed in both fore and aft locations and serve to limit seat travel during adjustment of the seat location. McFarlane seat rail part number MC1210408-22 was originally designed, approved and manufactured without the two forward seat stop holes. McFarlane has since learned that two forward seat stop holes are needed. Without a seat stop installed in a forward stop hole, it is possible the seat may slide far enough forward to come off the seat rail during seat adjustment.

**Figure 1.** Detail "A" shows seat stop holes properly located in the seat rail. The forward seat stop holes, as shown in Detail "A", were not installed on the affected seat rails.

- Drill the stop holes, located as shown in Figure 3. After drilling, measure the stop hole locations and diameters to ensure they meet the requirements of Figure 3.
- Install seat stop as shown in Figure 1 using hardware specified in the applicable Cessna aircraft parts catalog number P703-12.
- Proceed to Step 5.

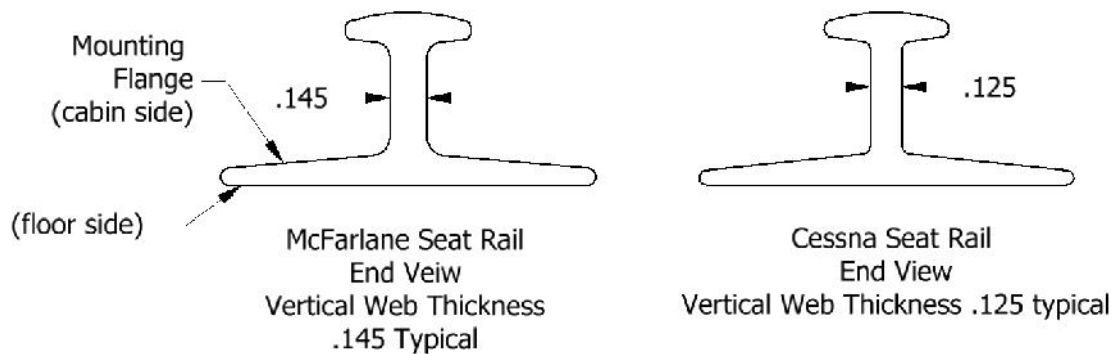
All McFarlane seat rails are marked with their part number and lot number during manufacture. The markings were applied using either stamped ink, engraving, adhesive backed labels or a combination of these methods. Markings may have been placed on the cabin side OR the floor side of the mounting flange as seen in Figure 2. Markings placed on the “floor side” of the mounting flange will not be visible unless the seat rail is removed from the aircraft. If the markings are not visible, the McFarlane seat rails may also be identified by measuring the thickness of the vertical web as shown in Figure 2. The McFarlane seat rails will have a thicker vertical web than the Cessna manufactured rails.

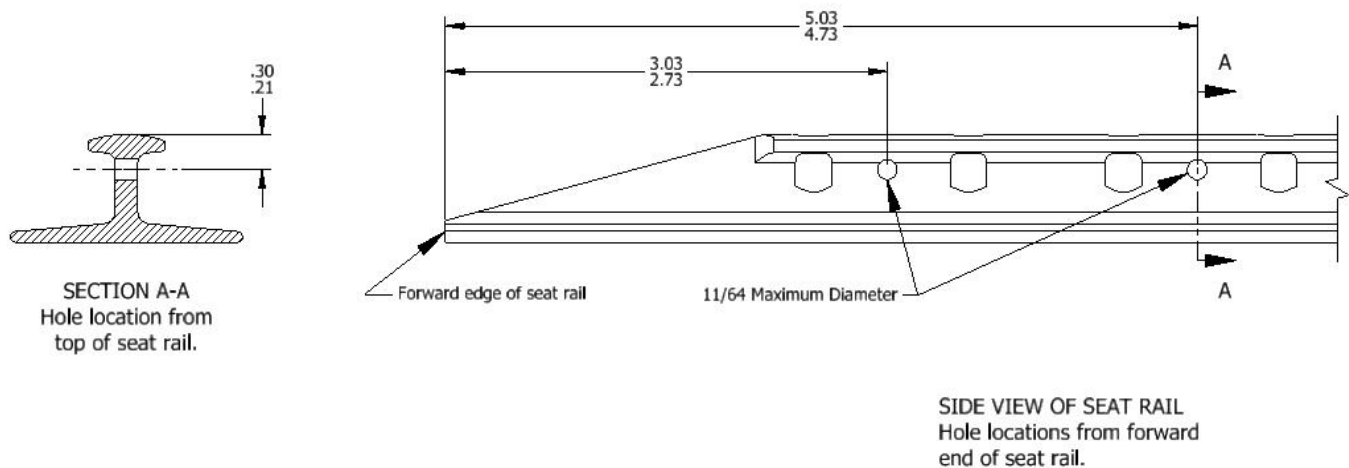
- If the seat stop holes have been installed, measure their location and diameter and compare to the dimensions shown in Figure 3. The stop holes must be located and have a diameter within the tolerance shown. If the stop holes are present and located properly, proceed to Step 5.
- If no stop holes are present, proceed to Step 3.
- If the holes are present but do not meet the dimensional requirements of Figure 3 then the seat rail must be replaced. Proceed to Step 4.

**Figure 3.** Seat stop hole location and diameter requirements.
