**Instructions for Continued Airworthiness**  
**McFarlane Aviation, LLC. FAA-PMA Part Number MC14064-102 CABLE, MC14064-103 CABLE,**  
**MC14065-101 CABLE, MC27050-101 CABLE.**  
FAA PMA Number: PQ3732CE

## INTRODUCTION

## SYSTEM DESCRIPTION

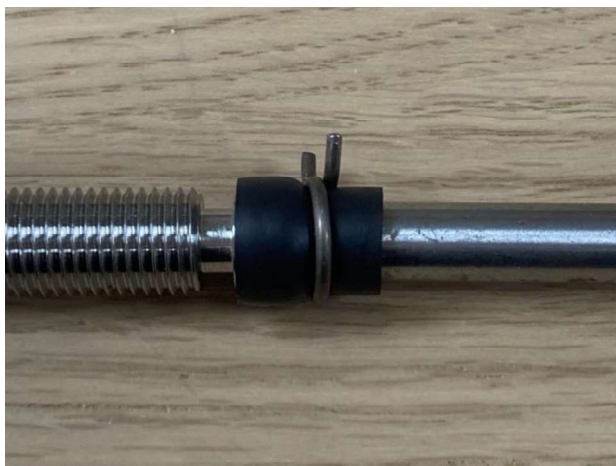
Figure 4: Correct installed position of P/N EC04 boot

- Slide the rubber tube component of EC04 boot over the push rod and guide tube.
- Work the tube component of EC04 boot over the end of the conduit terminal. The tube is in correct position when one of its ends is flush with the mounting groove on the conduit terminal, as shown in Figure 4.
- Slide the spring clamp component of EC04 boot over the push rod and guide tube.
- Install the spring clamp on the transition in the tube between the conduit terminal and guide tube. The spring clamp should be over the guide tube, but as close to the conduit terminal as possible.
- Install P/N 235 boot per "Installation" process above.
- When the control is completely reinstalled, ensure the quadrant and appliance control arm have full travel. If not, rig control so full travel is achieved. Refer to applicable Cirrus Aircraft Maintenance Manual for rigging instructions.
