Instructions for Continued Airworthiness
McFarlane Aviation Inc. FAA-PMA Part Number MC88409-002 Baggage Door Lock Kit.
FAA PMA Number: PQ3732CE

This document is intended to provide for the continued airworthiness of McFarlane Aviation, Inc. PMA Baggage Lock Assembly Kit eligible for installation on various Piper model aircraft. The kit part number is MC88409-02 and is comprised of the parts required to replace the baggage door lock located in the nose of the aircraft. This document specifically concerns the installation of the McFarlane Aviation lock assembly kit. For all items not related to the installation of the McFarlane Aviation, Inc. kit, refer to the basic airplane model service, parts manuals, and Piper SB1194. The McFarlane kit is a direct replacement for the Piper kit 88409-02.

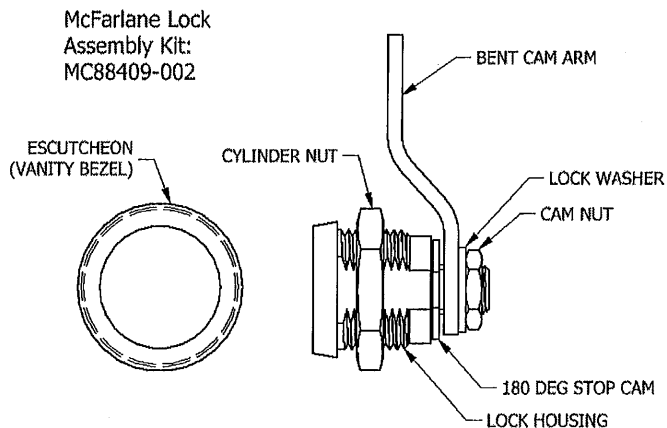
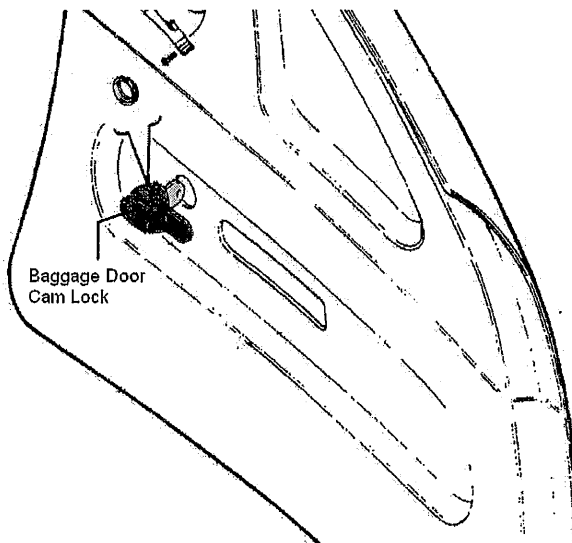
The McFarlane Aviation, Inc. pre-assembles the lock component of the kit as indicated. All parts are used. Note: For the Piper kit, Piper ships the components loose and includes several components that are discarded before installation.
